## Test Report No. 22081A

Solar Limpet

Fire Tests on Building Materials and Structures – Classification and method of test for External Fire Exposure to Roofs, according to BS 476 - Part 3 (2004).

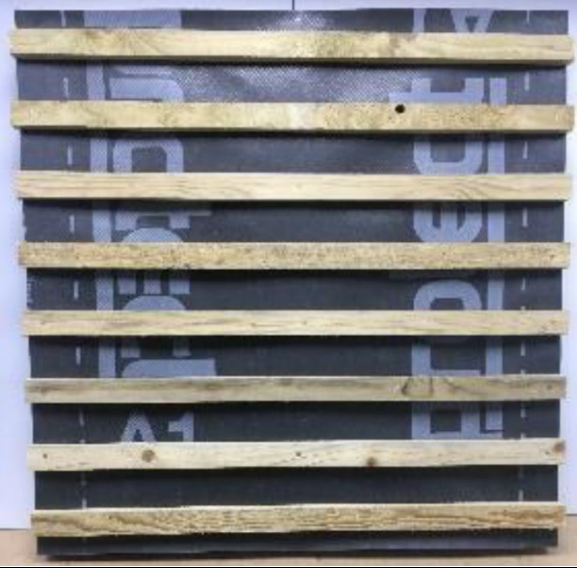
Nominal values (1)	Measured values (2)
<b>VAPOUR BARRIER</b>		
Material	A polymeric composition AVCL, comprising of a polypropylene non-woven layer, coated on one surface with a continuous film of polypropylene / polyethylene blend.	
Trade name	Protect A1	
Manufacturer	Glidevale protect	
Supplier	Glidevale protect	
Thickness (mm)	0,6	(4)
Surface weight (g/m <sup>2</sup> )	145	(4)
Flame retardants	No	(3)
Fixing method	Fixed with timber battens	
<b>WOODEN SUPPORT STRUCTURE</b>		
Material	Supporting structure, created by mechanically fixing wooden battens horizontally onto the vapour control layer.	
Photograph:

Thickness (mm)	25	(4)
Distance between battens (mm)	100	(4)
Dimensions (mm x mm)	38 x 835	(4)
Surface weight (g/m) of one batten	375	(4)
Flame retardants	No	(3)
Fixing method	Mechanically fixed

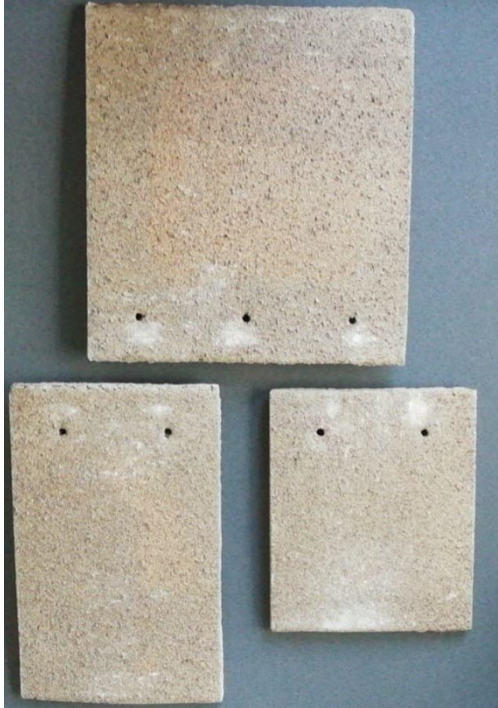
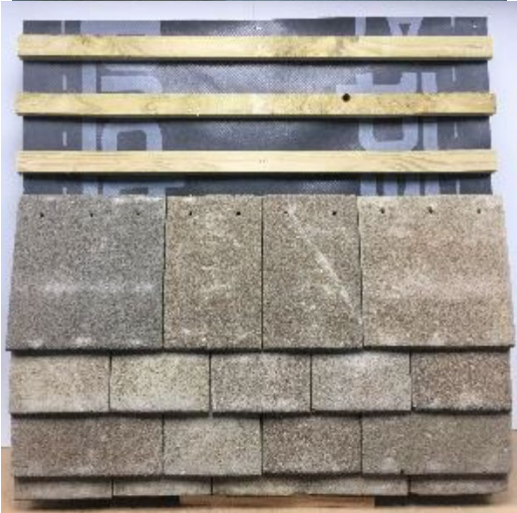
ROOF COVERING		
1.1 <u>First layer</u>		
Material	Concrete roof tiles	
Photographs:

Trade name	Plain Tiles	
Manufacturer	RedLand	
Supplier	Solar Limpets Ltd.	
Thickness (mm)	13	11,5
Surface weight (kg/m <sup>2</sup> )	75	(4)
Dimensions	Variable	(4)
Flame retardants	No	(3)
Fixing method	Mechanically fixed

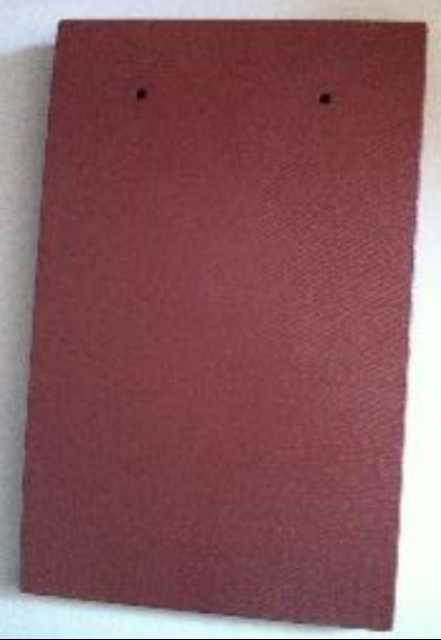
1.2 <u>Second layer</u>		
Material	A PVC tile built-in around the solar limpet, to replace ceramic tiles that broke or are vulnerable to breaking.	
Photograph:

Trade name	Blank tile	
Manufacturer	Solar Limpets Ltd.	
Supplier	Solar Limpets Ltd.	
Colour	Brown	
Thickness (mm)	13	13,2
Surface weight (kg/m <sup>2</sup> )	21	(4)
Dimensions (mm x mm)	168 x 260	(4)
Flame retardants	No	(3)
Fixing method	Mechanically fixed

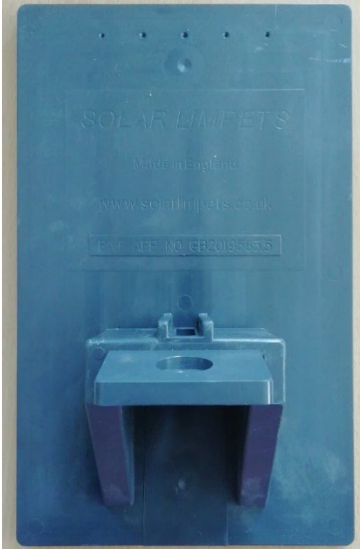
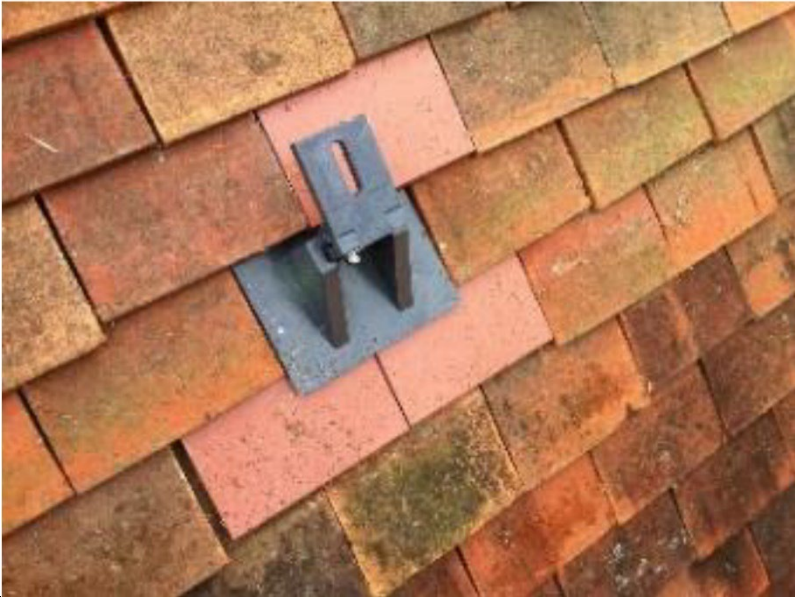
1.3 Third layer		
Material	PVC tile built into an existing roof, so that it can hold PV-modules. There is an adjustable plastic part, allowing more space for a PV-module.	
Photographs:

Trade name	Solar Limpet	
Manufacturer / Supplier	Solar Limpets Ltd.	
Thickness of the tile (mm)	10	9,7
Maximum thickness with the adjustable part (mm)	109	109
Dimensions (mm x mm)	165 x 268	(4)
Surface weight (kg/m <sup>2</sup> )	39	(4)
Flame retardants	No	(3)
Fixing method	Mechanically fixed

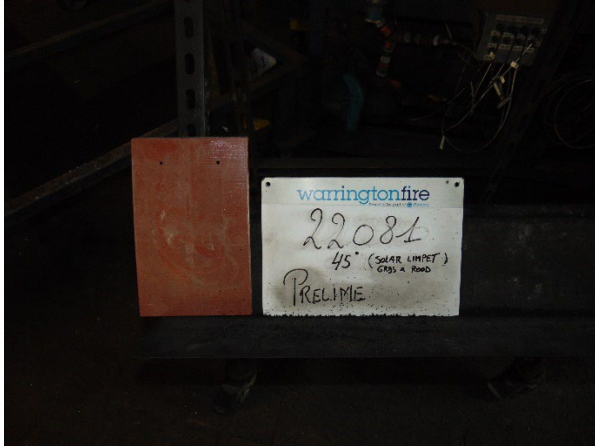
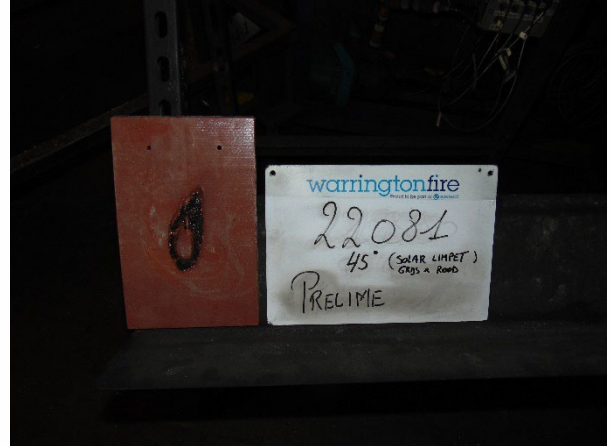
Specimen 1.1: Before

Specimen No:	1.1 (*)	1.2 (*)	Criteria
Duration of flaming after withdrawal of the test flame (min:sec)	00:00	00:00	< 5min
Maximum flame spread distance (mm)	95	120	< 380mm
Time to fire penetration (min:sec)	Did not penetrate	Did not penetrate	No penetration
Nature of the penetration	N.a.	N.a.	-

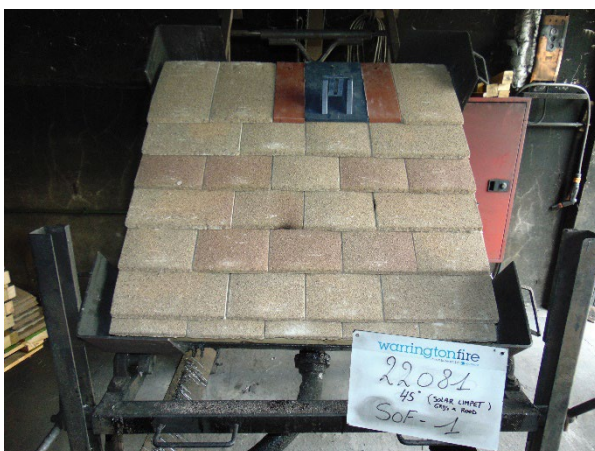
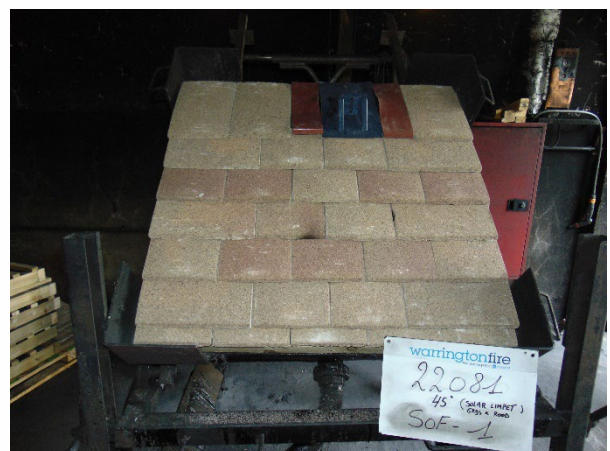
Specimen 2: Before

Specimen No:	2	3	4	Average	Criteria
Maximum downwards flame spread distance (mm)	0	0	0	0	≤ 533mm
Duration of flaming after withdrawal of the test flame (min:sec)	00:00	00:00	00:00	00:00	-
Additional observations: Carbonization and melting of the solar limpet and blank tile were visible for all specimens.

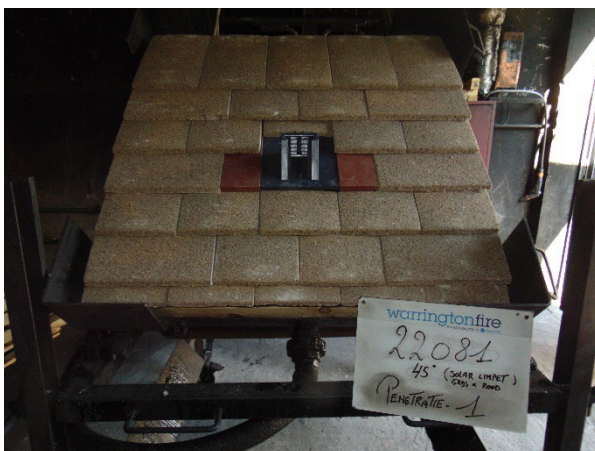
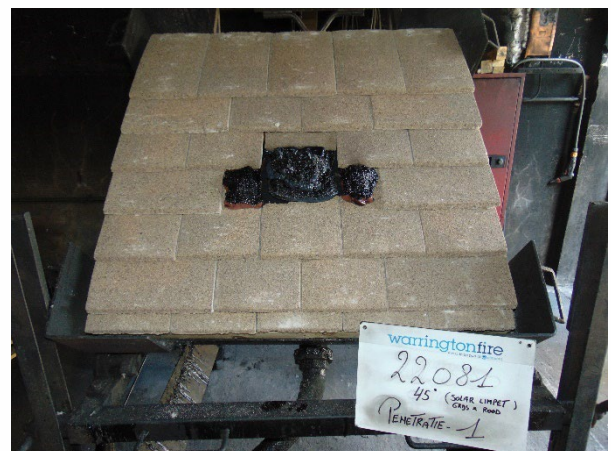
Specimen 5: Before

Specimen No:	5	6	7	Average	Criteria
Time to fire penetration (min:sec)	Did not penetrate	Did not penetrate	Did not penetrate	Did not penetrate	30min or 60min
Nature of the penetration	N.a.	N.a.	N.a.	-	-
Additional observations: Carbonization and melting of the solar limpet and blank tile were visible for all specimens.
