BRE Test Report

Wind Uplift, Weathertightness and Snow Load Testing of Solar Limpets Solar Technology PV Mounting Bracket Clamps to MCS012

Prepared for: Carl Reynolds
Date: 21st July 2021
Report Number: P120784-1000 Issue 2

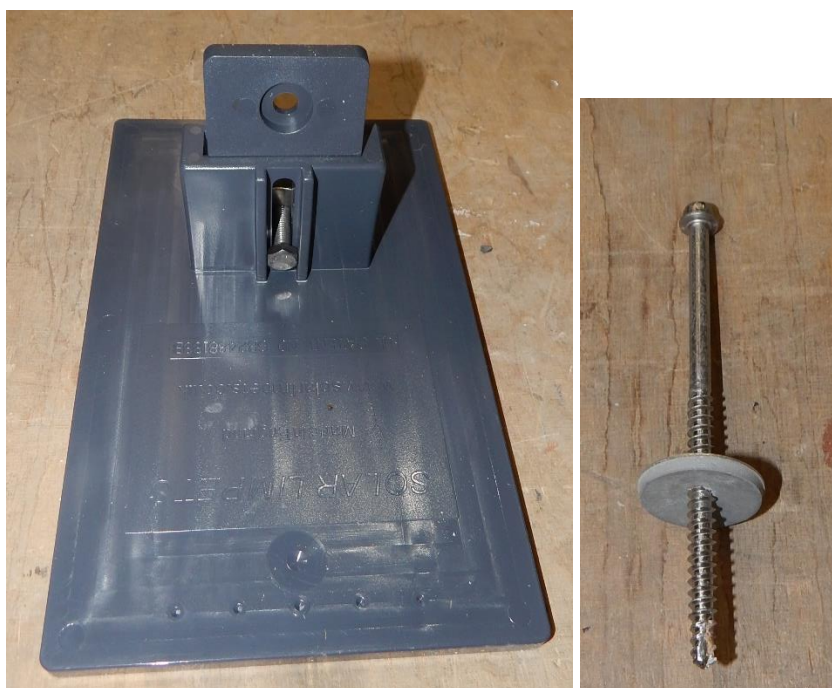
The Grade A PVC plastic bracket had baseplate dimensions of 265mm x 170mm x 10mm, and a removable vertical bracket fixed in place with a bolt. The bracket was fixed via two 115mm length x 6.5mm stainless steel Mage screws with a 22mm diameter stainless steel and EDPM washer, Figure 1.

Figure 1 Components of the bracket and fixings.

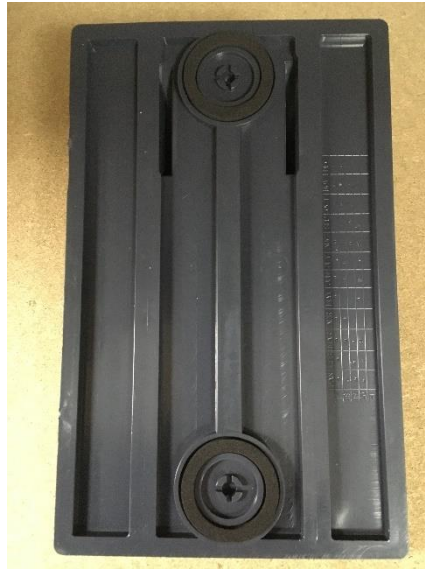
For the slate application, the underside design allowed for an EDPM seal and a capture for the CT1 liquid sealant applied to the slate surface during installation, Figure 2.

Figure 2 Underside of plastic PV bracket.

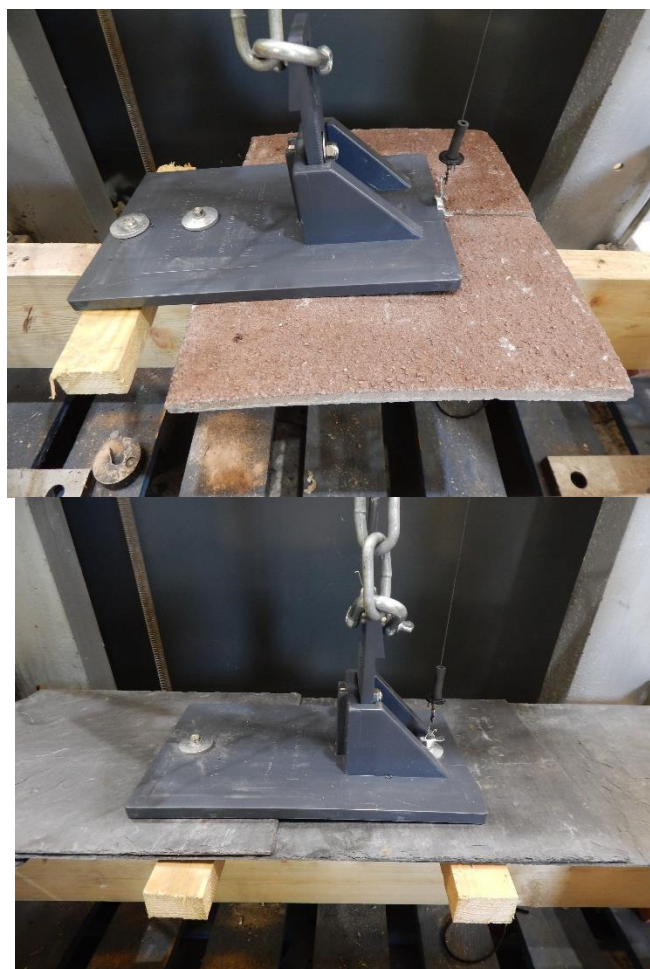
Since there is no British Standard test specifically for assessing the wind uplift resistance of fixing brackets for solar modules, the testing was carried out using the principles of wind uplift testing described in MCS012 and BS EN 14437:2004. The brackets were fixed to the roofing elements and to a timber rafter using the screws provided by Solar Limpets Ltd. A chain was attached to the top of each bracket. A hydraulic ram and a calibrated load cell were attached to the loading chain. The ram was mounted on a cradle, which allowed movement in both horizontal axes, and, combined with the chain, allows the bracket to rotate as it would in practice when subjected to a wind uplift load. Calibrated displacement transducers were fixed to the bracket end and to the bracket base plate.

Load was applied to the bracket in increments of up to 1/20 of the estimated failure load. At each load increment the displacement of the bracket and base plate were measured. The bracket was then unloaded, and the residual displacement of the bracket edge and base plate were measured. The failure load was considered to be the load at which the residual displacement at the bracket end reached 5mm, as defined in BS EN 14437:2004 or when there was a mechanical failure of the bracket. The 5mm displacement is only relevant where a gap is formed in the roof elements that would affect the weathertightness of the roof. In this case, this can be ignored. Loading and unloading were both carried out at a rate of approximately 50 N/s. Figure 3 shows the test setup.

Figure 3 Example of the setup of the test rig with rafter, roofing element and bracket (plain tile top, slate bottom).

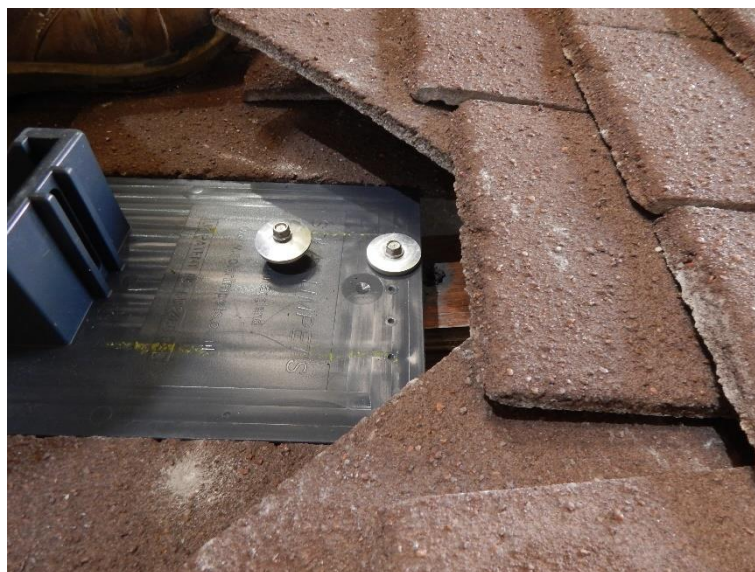
For the plain tiles, the installation guide was followed to install two brackets; one via fixing option 1 and one via fixing option 2. Figures 5 and 6 show the installation and final set up for fixing option 1.

Figure 5 Image to indicate the fixing of the brackets with the clay tiles.

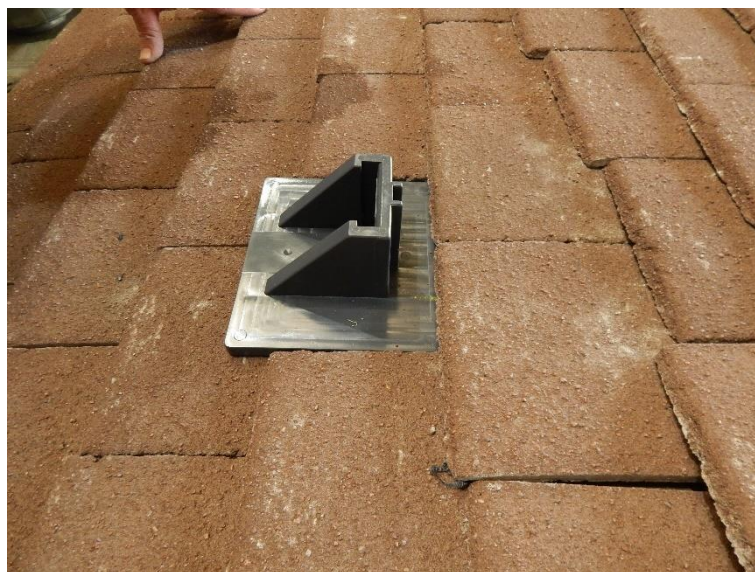
Figure 6 Image to highlight the test set up for the brackets with clay tiles.

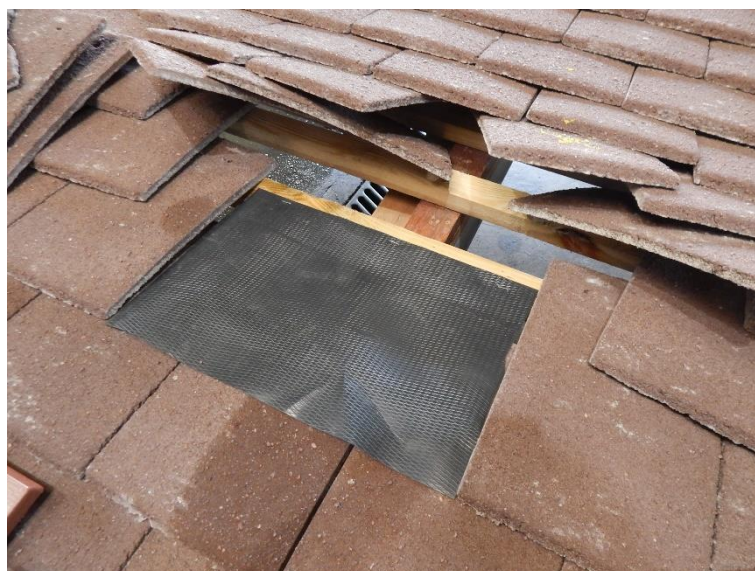
Figure 7 indicates the installation and final set up for fixing option 2. A 220mm wide section of damp proof membrane was laid on the roof and stapled to the roof batten prior to installing the bracket, as per the installation instructions, see Figure 8.

Figure 7 Inclusion of a standard damp proof course layer ensured weathertightness was maintained.

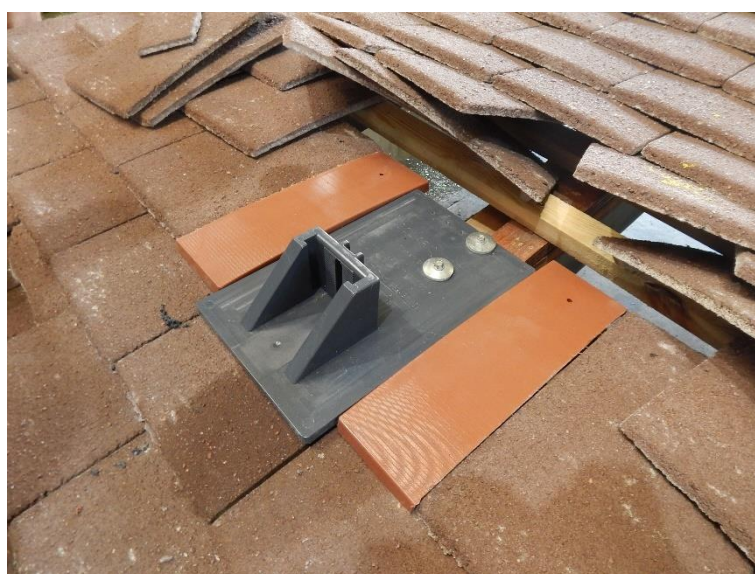
Figure 8 Fixing option 2 using blanking plates in the installation of the PV bracket.

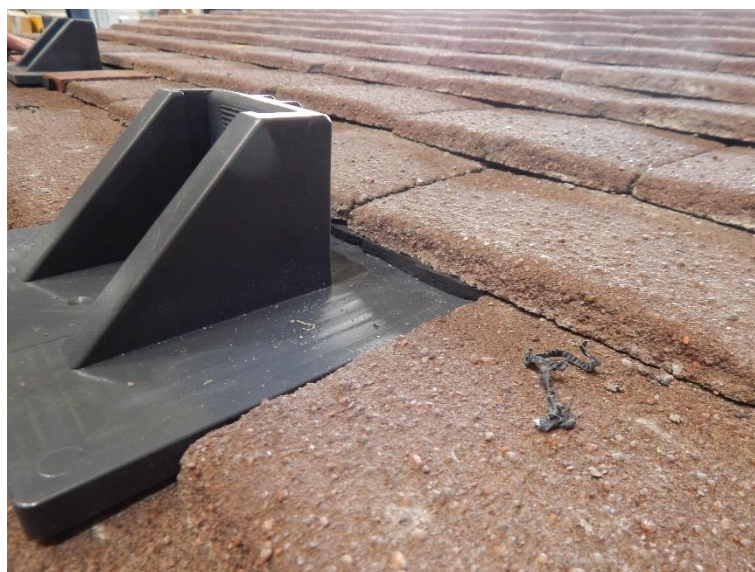
For both fixing options, the addition of the PV bracket with the plain tiles created an unprotected gap that was larger than the baseline roofing elements. A strip of 15mm thick EDPM foam was added to fill the unprotected gap in accordance with the installation instructions, Figure 9.

Figure 9 Image to highlight the gap created by the installation of the PV bracket with plain tiles and the EDPM foam used to seal the gap.

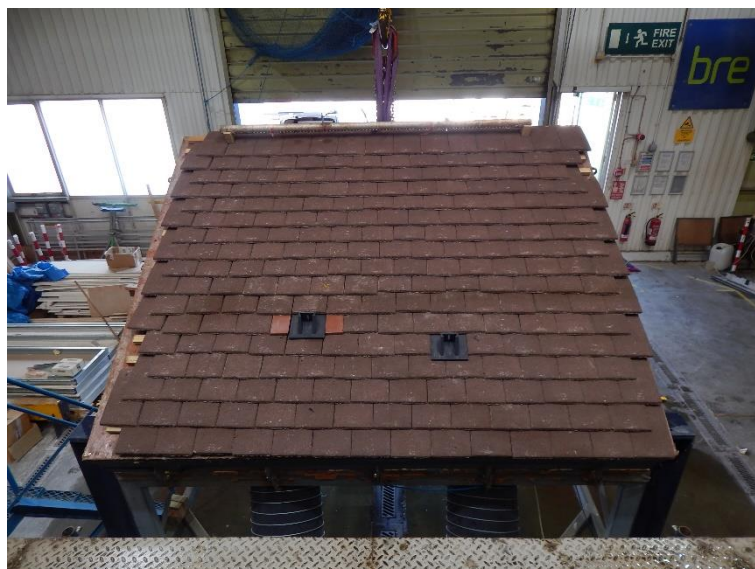
Figure 10 Test set up for Rosemary plain tiles.

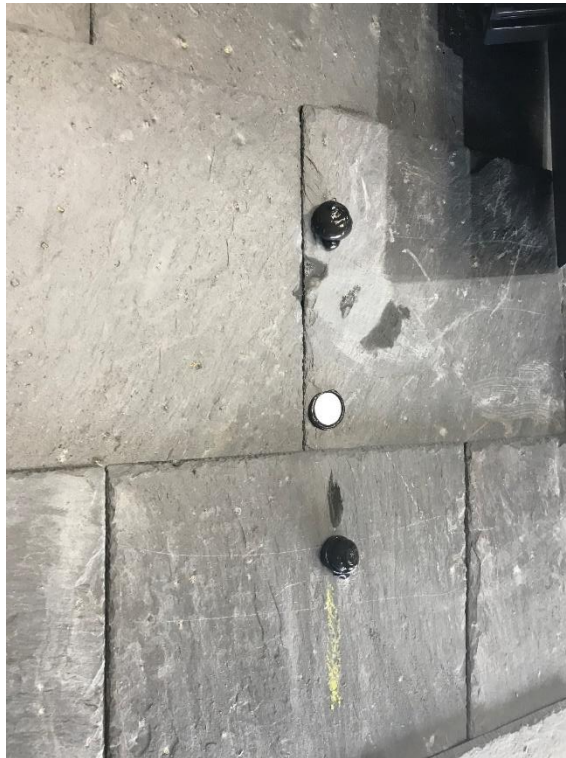
For the slate, again the installation instructions were followed. A collet pipe was not used in the installation since it is not required for this sized slate. Figure 11 shows the sealant used to seal the holes created by the drilling the fixing holes and Figure 12 highlights the set up of the PV bracket with slate.

Figure 11 Image to indicate the fixing of the brackets with the slates.

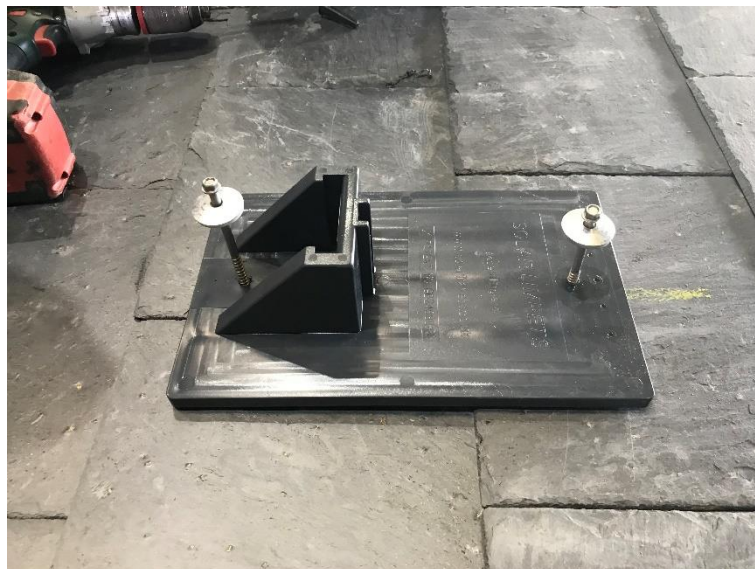
Figure 12 Image to highlight the test set up for the brackets with slates.

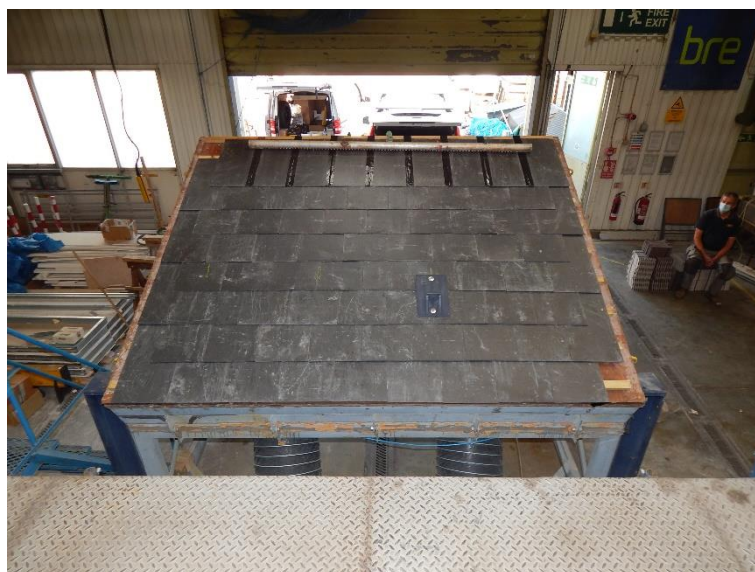
Figure 13 Test set up for PV brackets with slates.

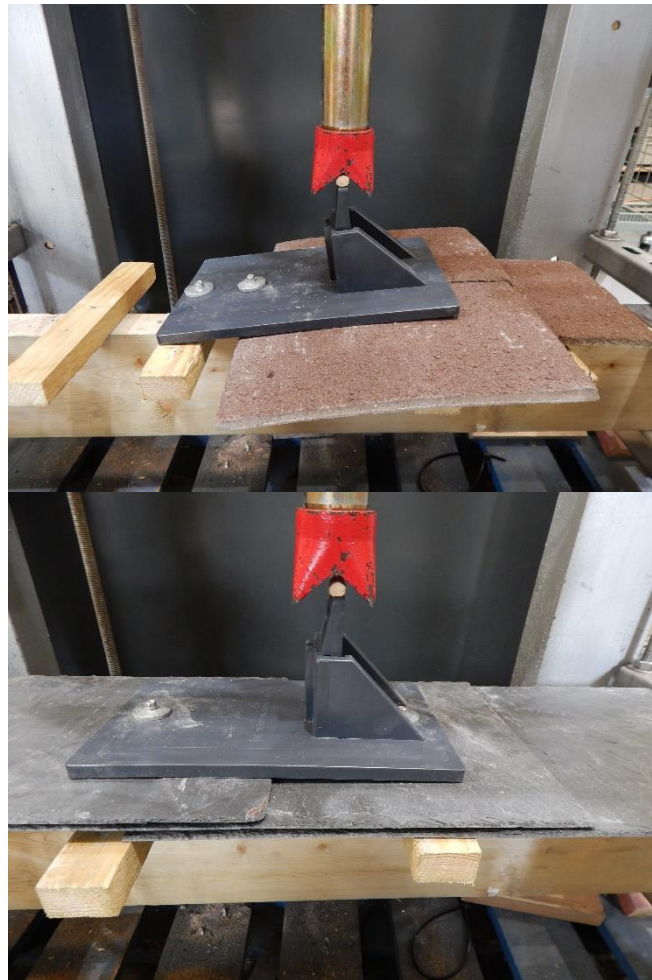
Since there is no British Standard test specifically for assessing the positive loading of fixing brackets for solar modules, the testing was carried out using the principles of wind uplift testing described in MCS012 and BS EN 14437:2004. The brackets were fixed to the roofing elements and to a timber rafter using the fixing strategy described by Solar Limpets. A hydraulic ram and a calibrated load cell were rested on the bracket. Load was applied to the bracket slowly until the failure load was achieved. Failure was determined to be when the roof element was damaged. Figure 14 shows the test setup.

Figure 14 Test set up for positive load test (plain tiles top, slate bottom).

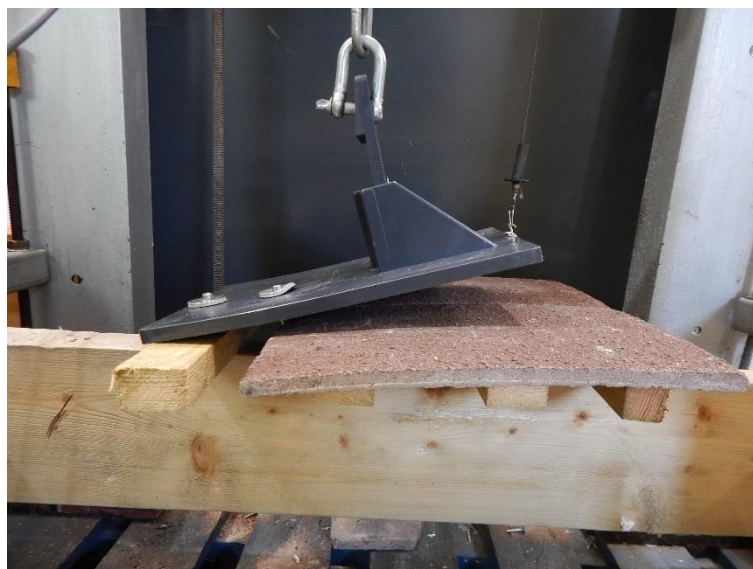
Table 2 gives the calculated values of R_k , R_x , s_x and s_x/R_x and the individual failure loads from each of the three tests on the plastic bracket with clay tile at the limit state. The coefficient of variability (s_x/R_x) is <0.1 therefore this is a valid test result. Figure 15 shows the bracket under test.

Figure 15 The bracket on plain tile under test at failure.

Failure of the system occurred as a result of the screw head being pulled through the washer and bracket, Figure 15. The failure load in the ultimate limit state (ULS) testing was taken as 1771.4N. A partial safety factor of 1.1 is applied.

This gives a design wind uplift resistance at ULS of $1771.4/1.1 = \mathbf{1610.4N}$

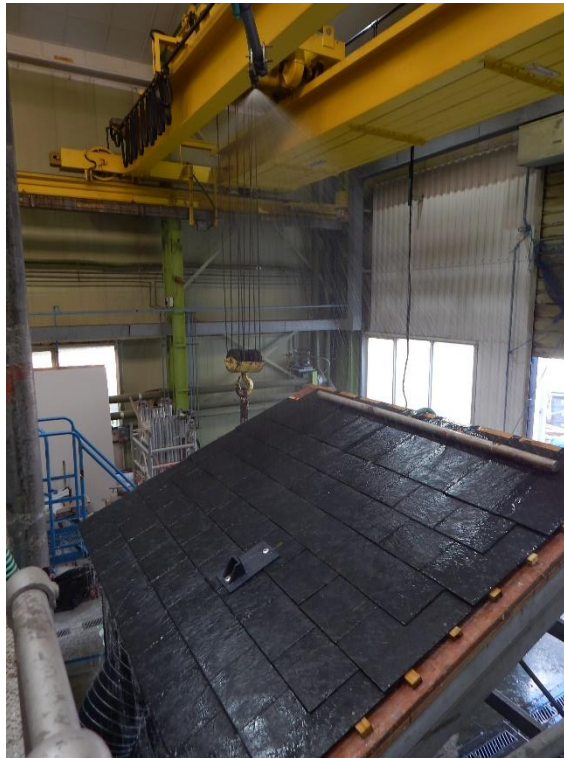
Figure 18 highlights the PV bracket undergoing deluge testing. No leaks were visible as a result of the PV brackets being installed.

Figure 18 Bracket with slate under deluge test.

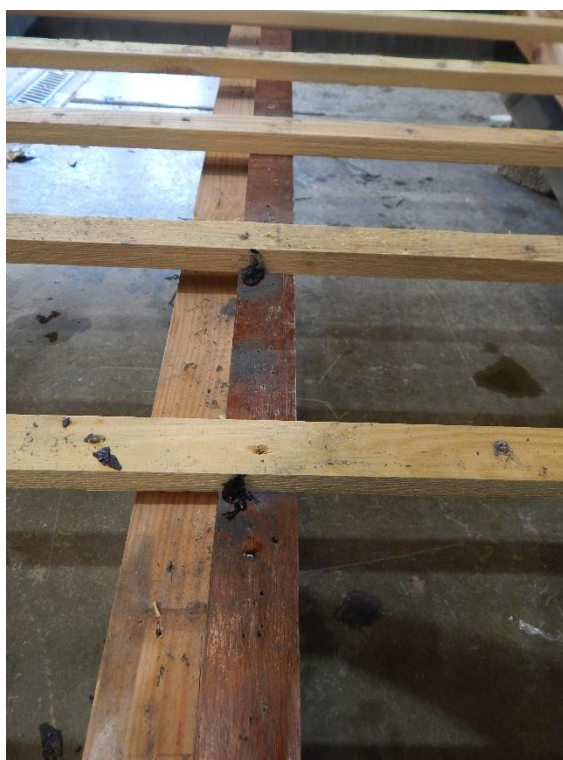
Upon removal of the PV bracket, it was noted that the CT1 sealant had sealed the entire fixing hole, as evidenced by the fact that there was sealant present on the battens and rafters where the bracket had been fixed. The secondary inner housing is designed to allow the CT1 liquid sealant, under the subsequent hydraulic pressure created when fixing the baseplate to the slate surface, to also penetrate the predrilled screw hole shaft, further sealing the screw penetration down to the rafter, Figure 19.

Figure 19 Image to highlight the CT1 sealant on the rafters after testing.

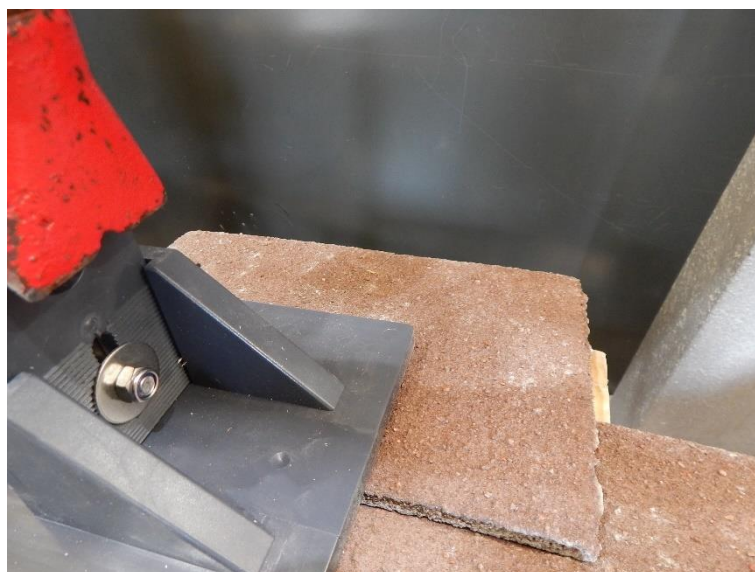
Table 6 gives the calculated values of R_k , R_x , s_x and s_x/R_x and the individual failure loads from each of the three tests on the plastic bracket with clay tile at the limit state. The coefficient of variability (s_x/R_x) is <0.1 therefore this is a valid test result. Figure 20 shows the bracket under test.

Figure 20 The bracket on plain tile under test.

Failure of the system occurred as a result of the tile cracking under load. The failure load in the ultimate limit state (ULS) testing was taken as **936.1N**. No partial safety factor have been applied.
